Contamination Examples and Lessons from low Earth orbit experiments and operational hardware

Dr. Gary Pippin,
The Boeing Company, Seattle, Wa 98108
and
Ms. Miria M. Finckenor
Marshall Space Flight Center, AL 35812

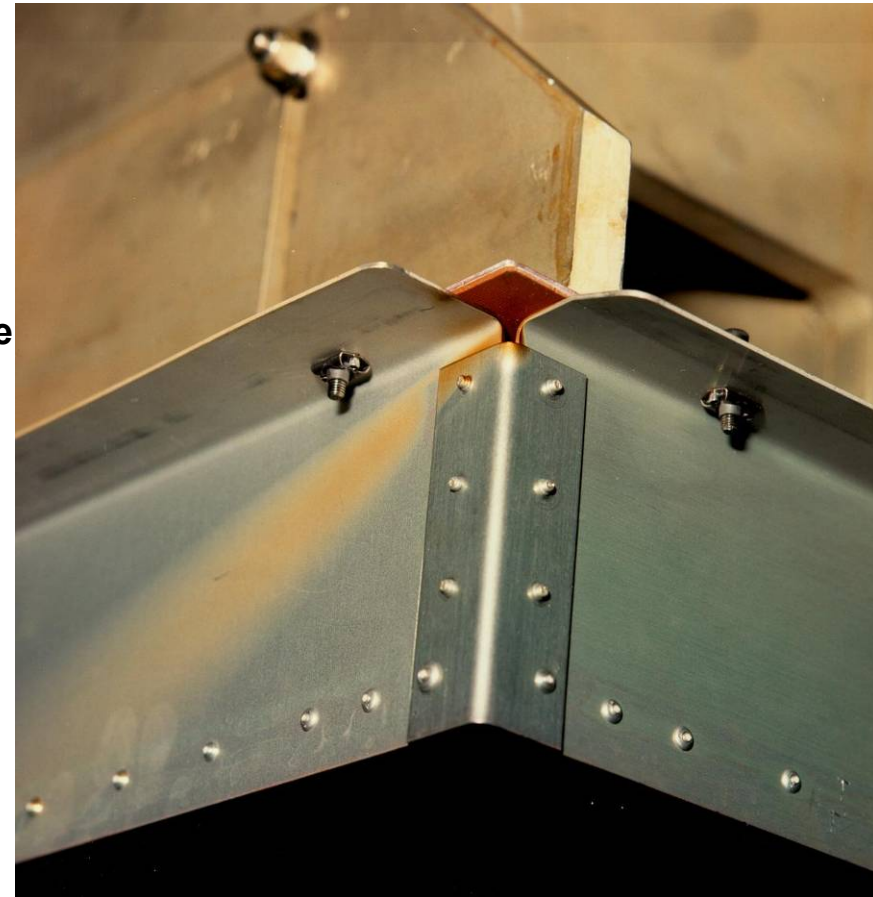
On-orbit induced changes to pre-flight contamination

- Prior to launch, trays were stored with aluminum lids that had silicone rubber gaskets along the tray perimeters
- The gaskets had a line-of-sight view to the exterior of the experiment trays
- Space Environment “fixed” the contamination to the tray surface
 - Volatile contaminants condensed on surface
 - In this case, AO oxidized silicones to SiO_2
 - Solar UV caused chain scission and cross-linking in polymers that resulted in browning
- Non-uniformity of discoloration is due to variation in thickness and AO and UV exposures

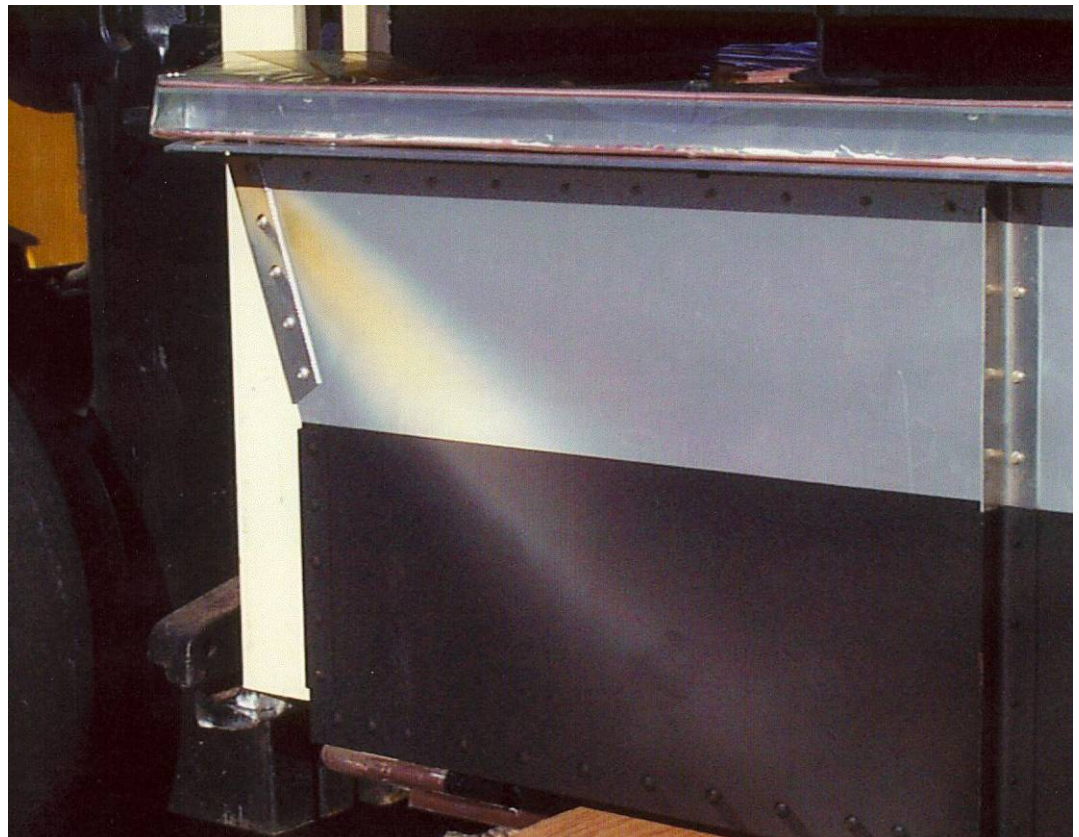
Depth-composition profiles on Contaminates

- During de-integration, large plumes of contamination were noticed on experiment tray panels
- Hypothesized that the plumes consisted of a range of thicknesses that corresponded to a range of environmental exposures

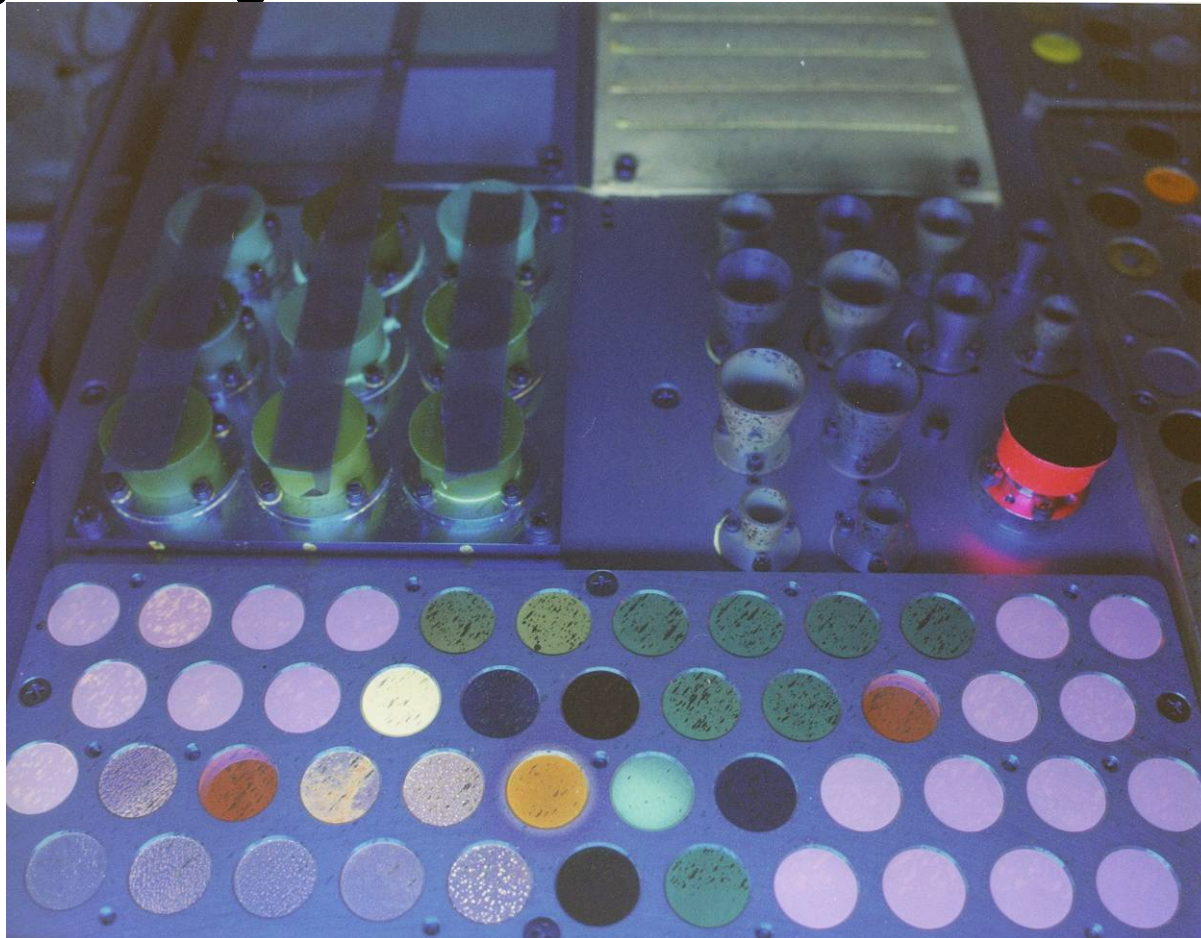
Results of contamination event on Mir

- **“Black-light” image of contamination on POSA II**

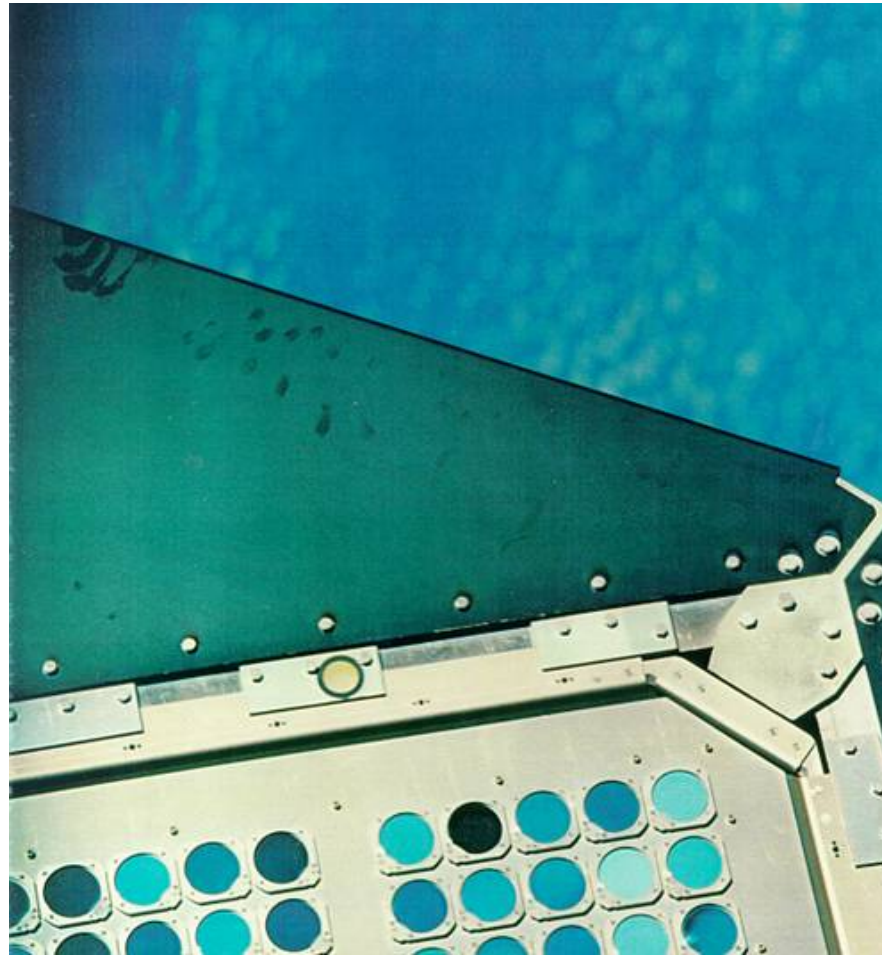
On-Orbit Effect due to Pre-flight handling

- **Fingerprints show up clearly on the anodized hardware**
- **Significant change in optical properties at location of contact**
- **These issues could be critical for small spacecraft where thermal control areas are limited**

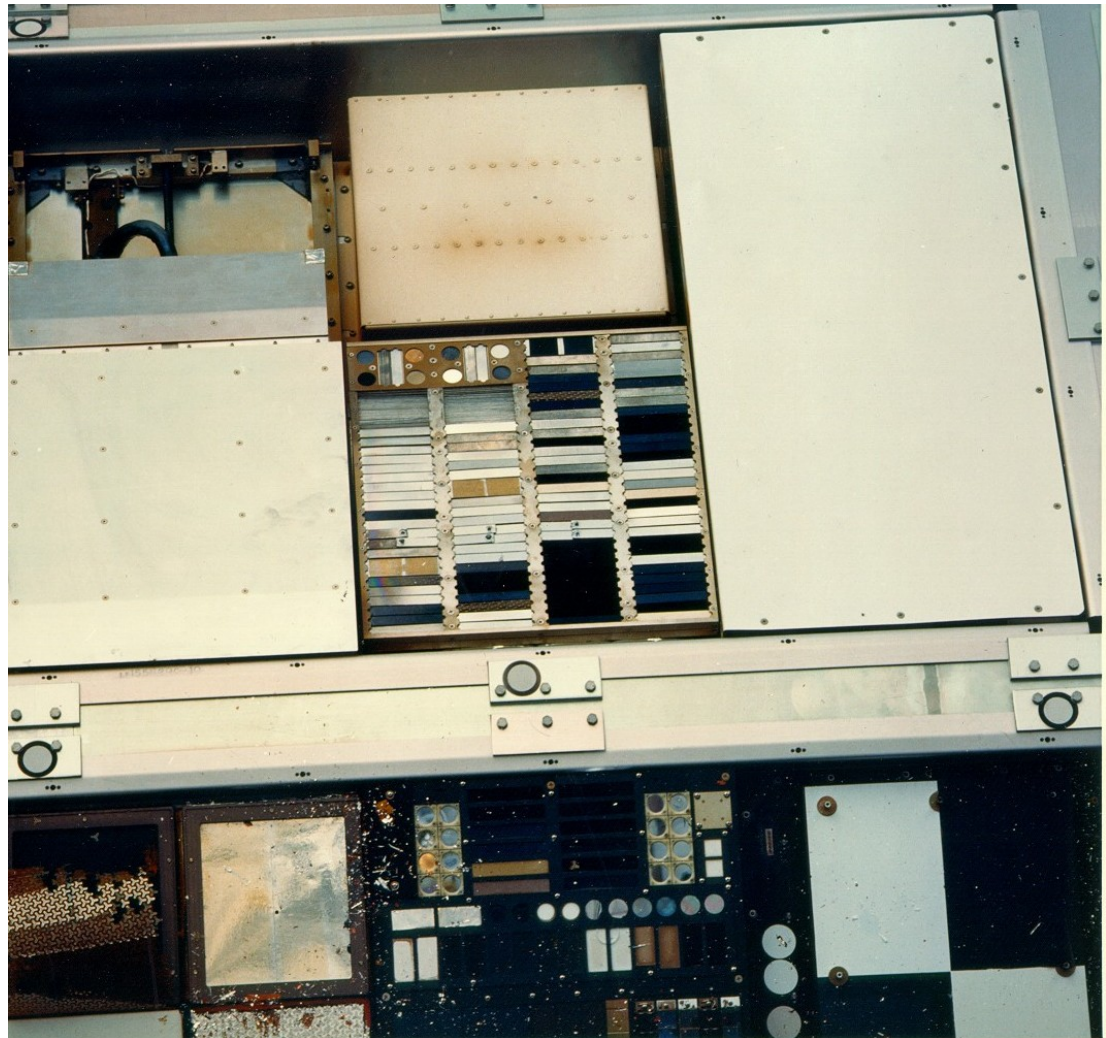
On-Orbit Events and Processes

- **Two contamination features are present**
- **Debris from one experiment has migrated onto an adjacent experiment (blown off during Re-entry)**
- **Darkening around fastener locations (similar effect on HST)**

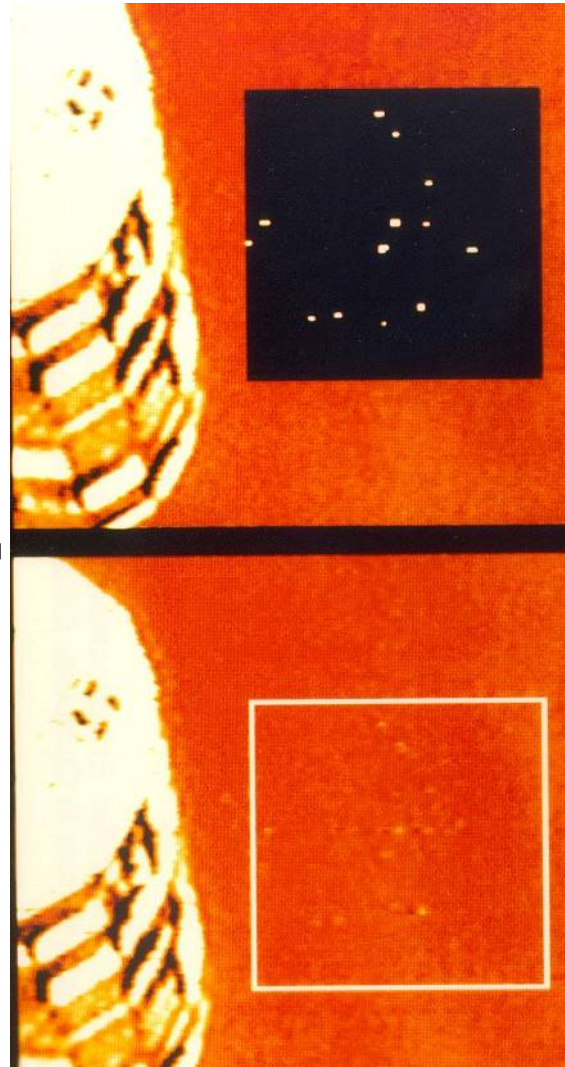
Debris Cloud in LDEF Wake

- **Mechanism must explain particle migration from ram side of LDEF**
- **Debris are aluminum foil from failed thin film**

Direction
Of Motion

Multiple frames
averaged

Single video
frame

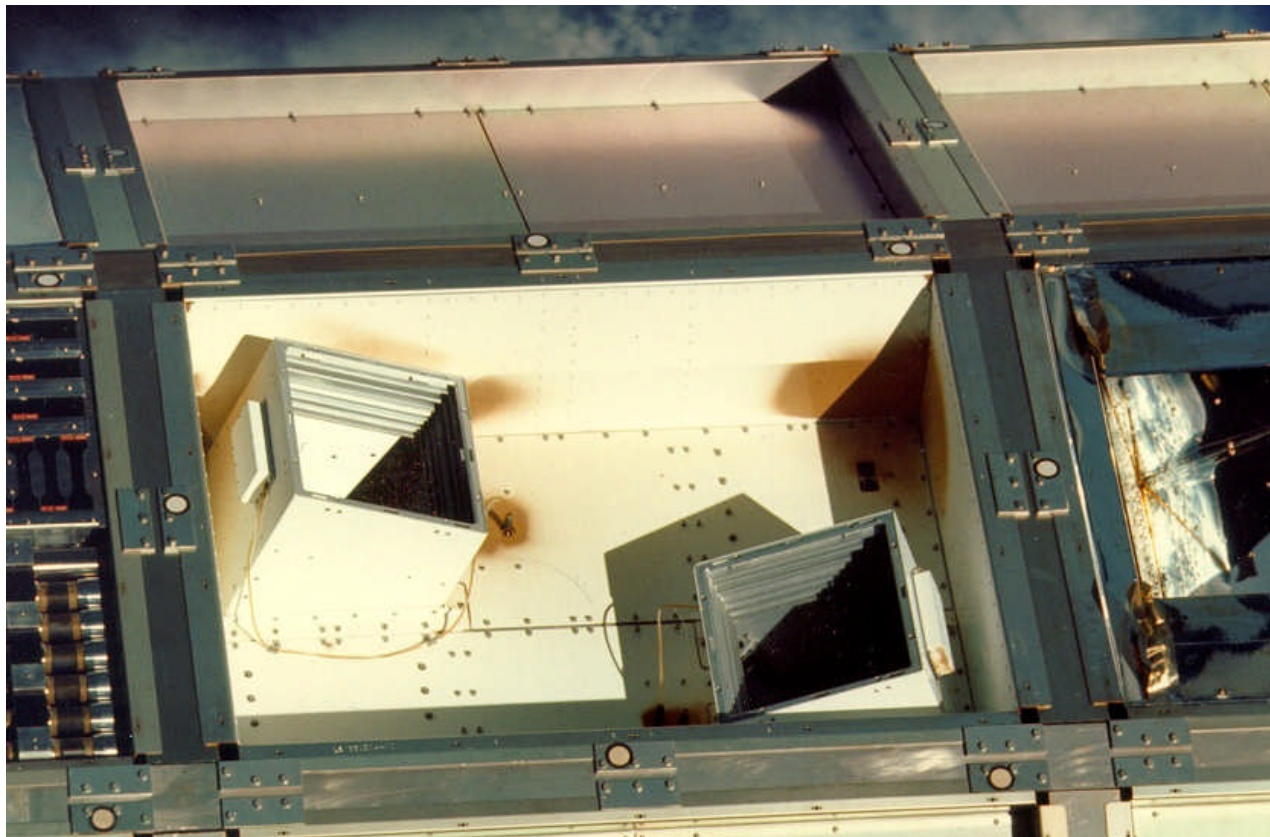
On-Orbit processes

- **Material depositions appear to be influenced by electrostatic effects, also thermal cycling**

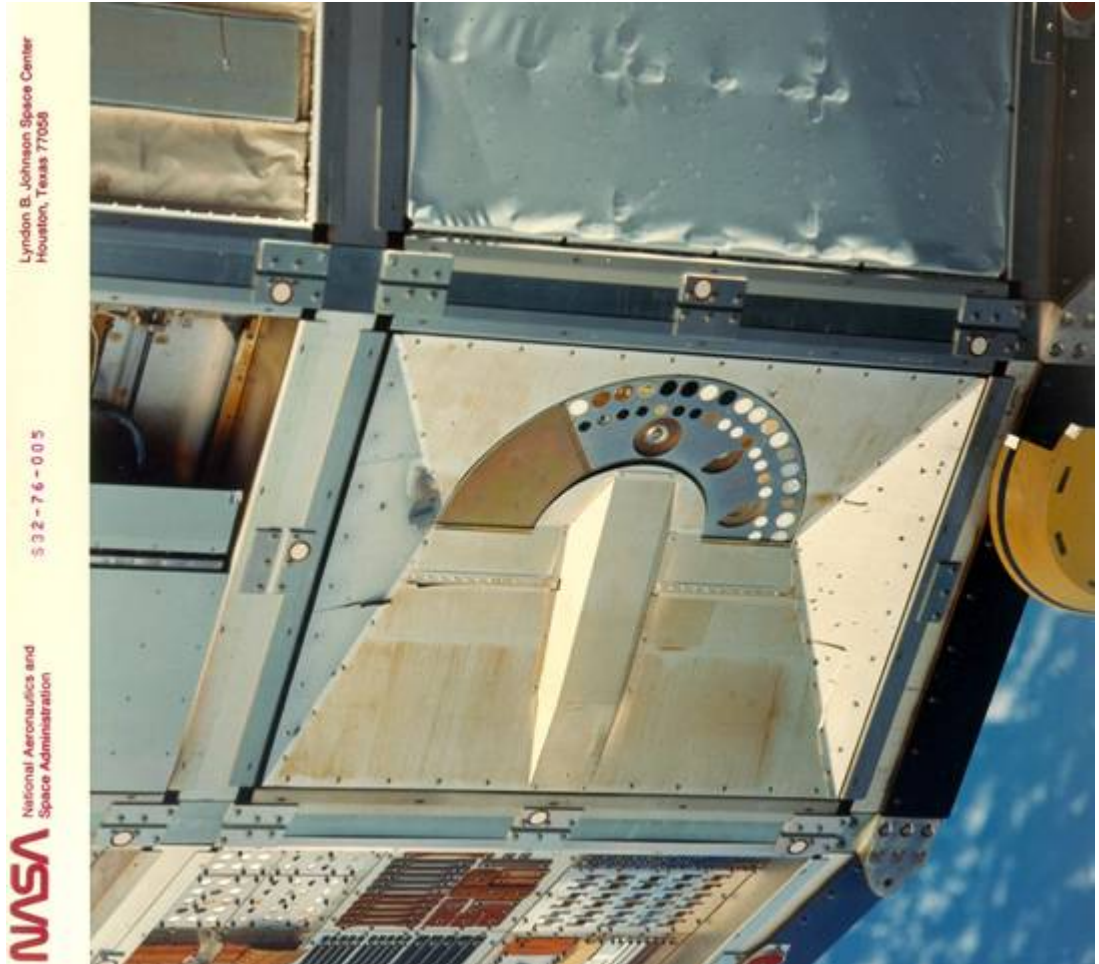
Solar Exposure induced changes

- **Not every observed discoloration is due to contamination**

Adhesive under FEP layer darkened by ~11000 Equivalent Sun Hours (ESH) of direct solar exposure

Adhesive “bled-through” cracks in silver-inconel layer created during application of film to substrate

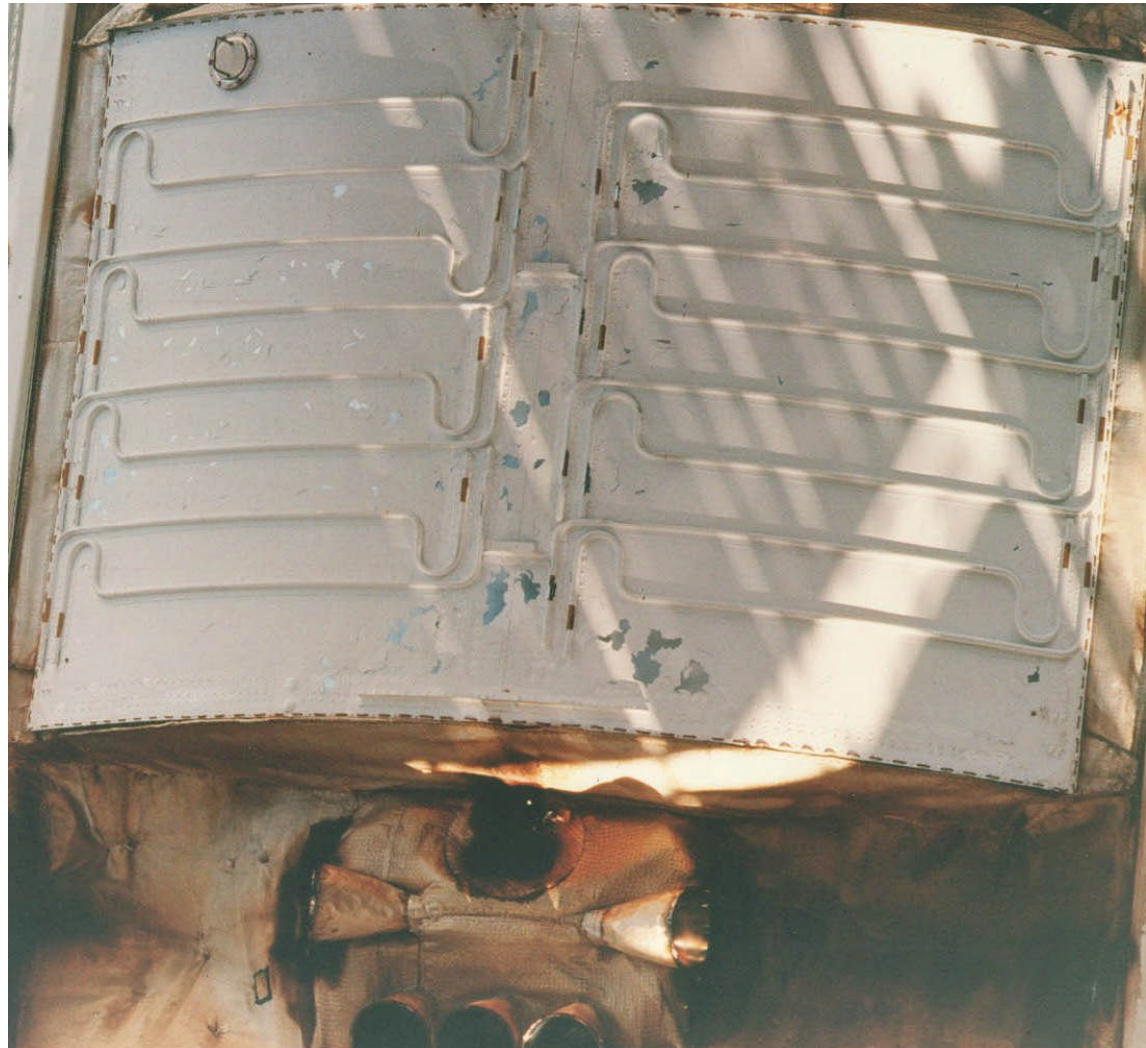
MIR “Contamination” Examples

- **Failure of paint adhesion**
- **Thruster plume contamination**

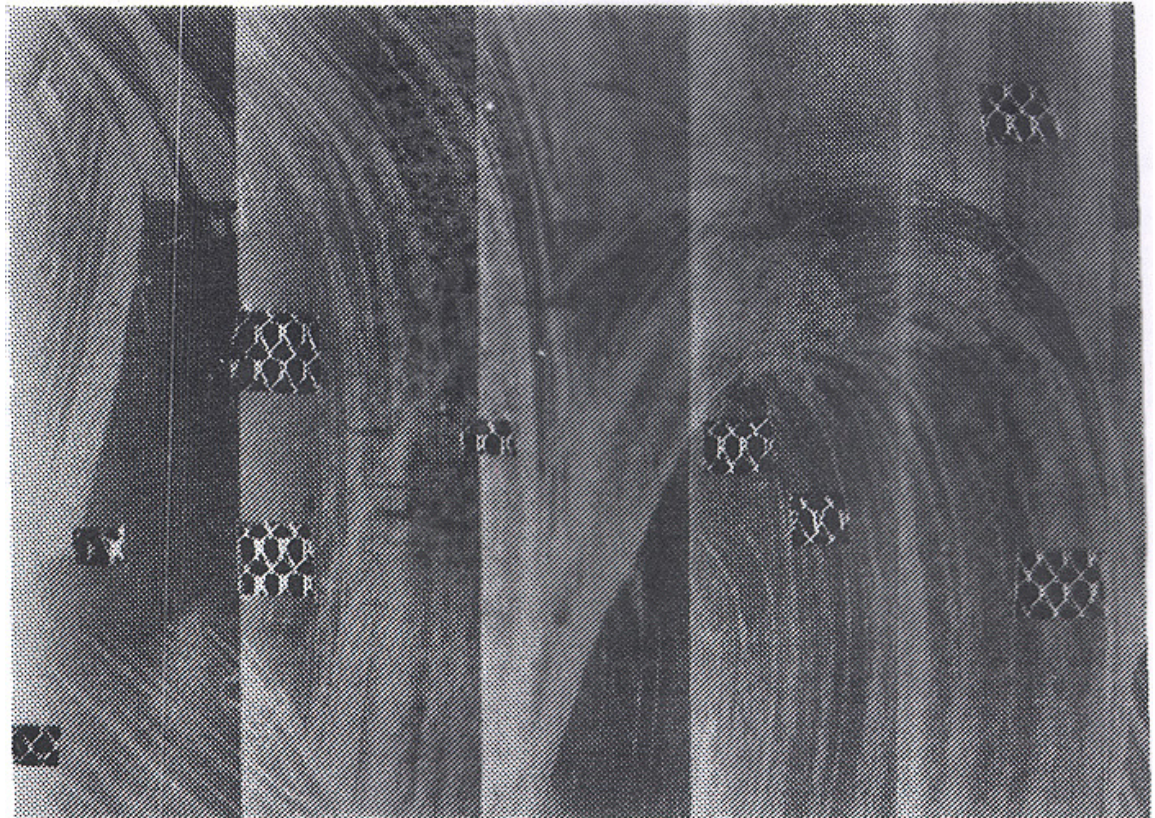
Pre-Flight “Cleaning”

- **Solar Max Kapton surface “wiped down” pre-flight**
- **On-orbit UV exposure induced changes**

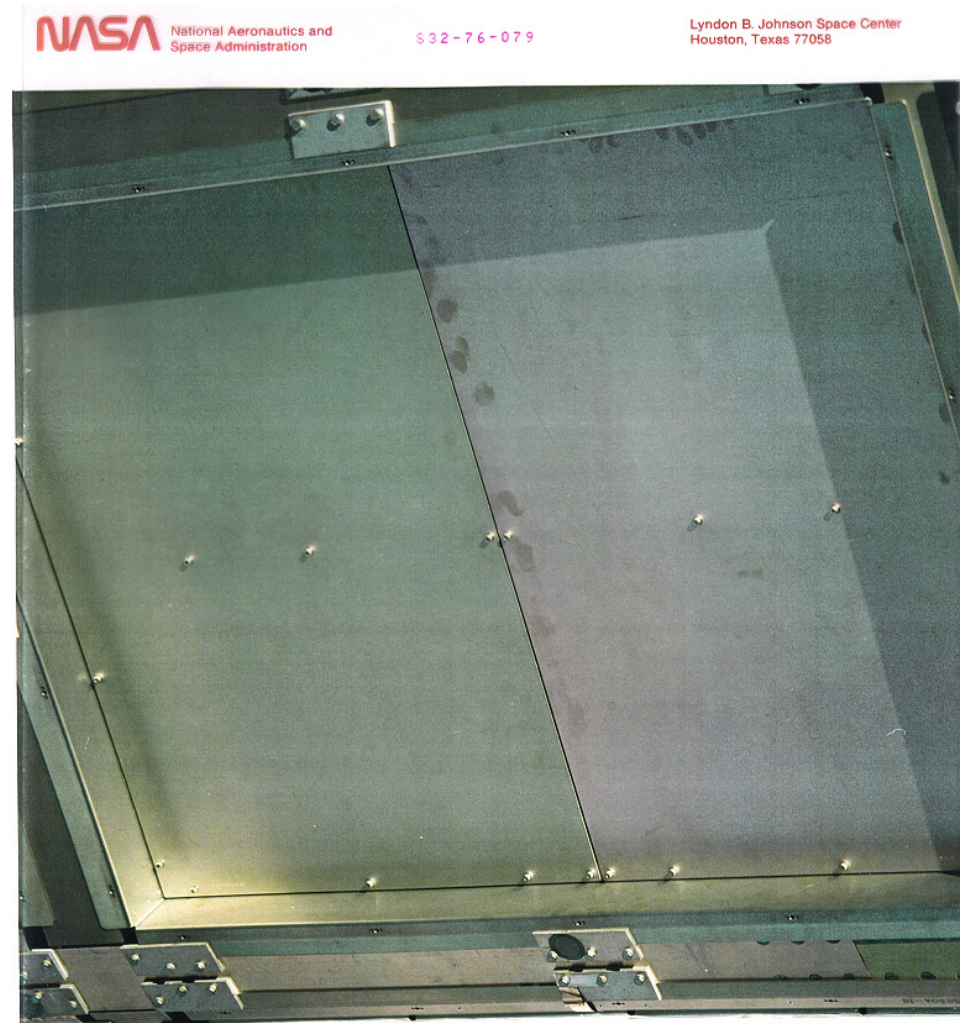
Assembly Procedure Issues

- **Thermal control panel installation shows use of un-gloved hands**

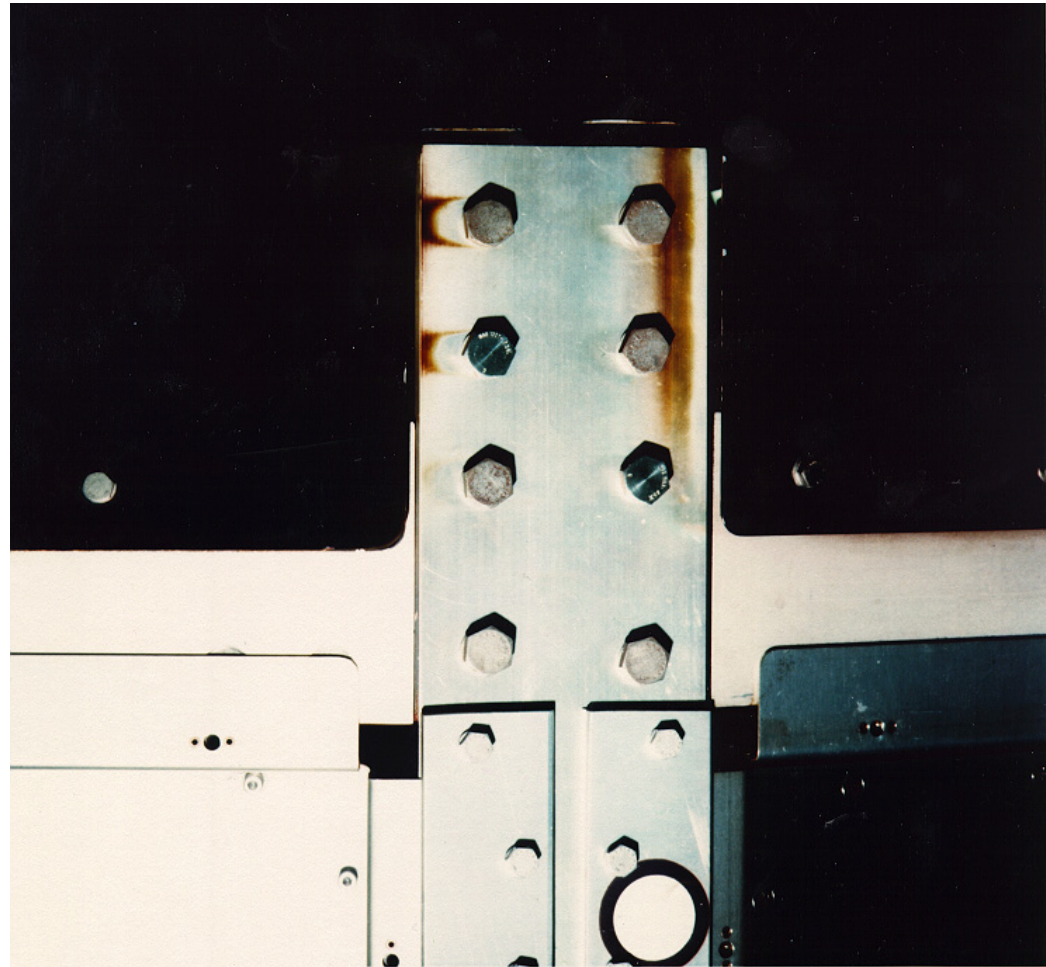
Post-deposition discoloration of outgassed materials

- Venting from LDEF interior is source of contaminant
- Details of the mechanism are subtle
- Pattern depends on at least 4 time-varying factors
 - Outgassing
 - Temperature
 - Atomic oxygen
 - Solar Exposure

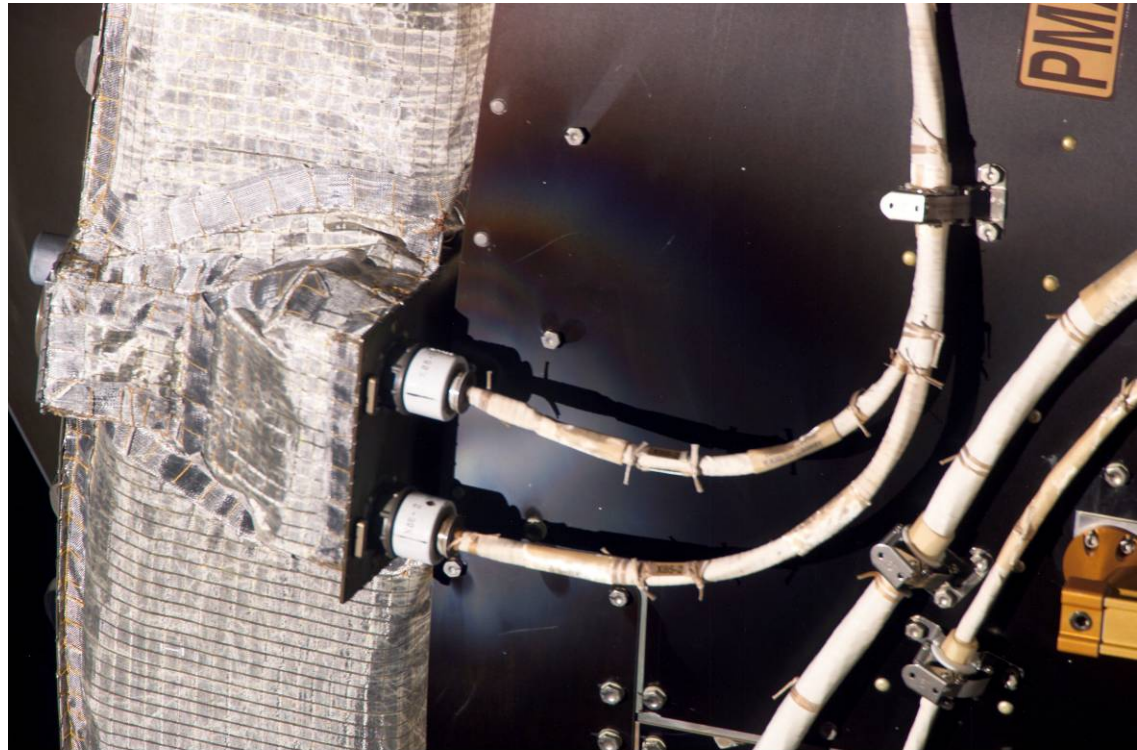
ISS013E37367

Pressurized Mating Adaptor-3 with Russian cables

- Either vent path or outgassing from cable connectors
- In general, contamination on ISS appears to be localized
- Material selection and stringent outgassing reqs.

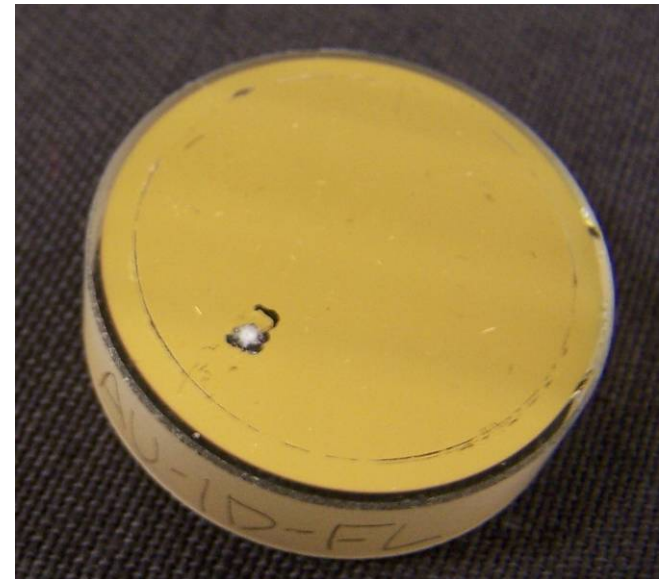
- **MISSE-2 Optical Witness Samples**

- Four years on orbit
- Ram side ~4 nm contaminant
- Wake side ~44 to 50 nm
- Mostly SiO_2
- Ellipsometry, ESCA in agreement with model predictions

Gold mirror with MMOD impact

These levels of contamination may be significant for optical surfaces

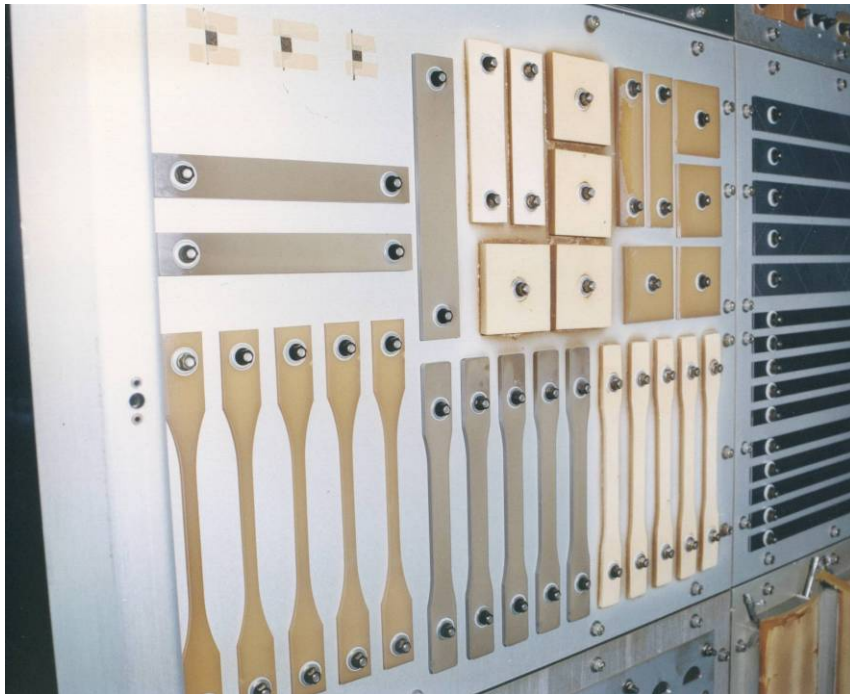
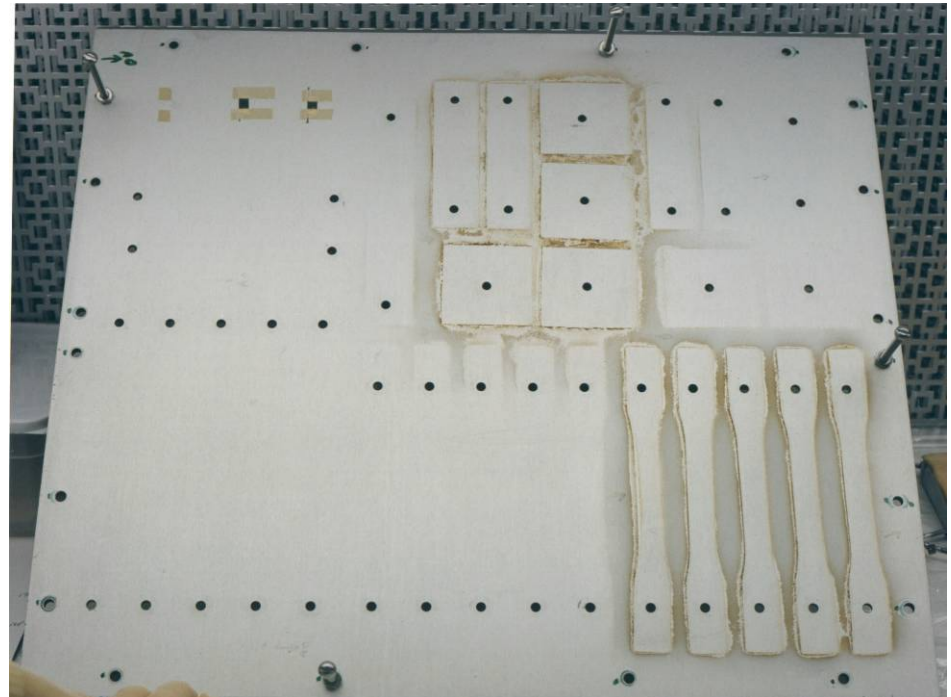
Long-term Outgassing On-orbit

- **contamination example from LDEF AO171 experiment**
- **Variety of molecular deposits**
 - Silicone, Fluorocarbon, Organic

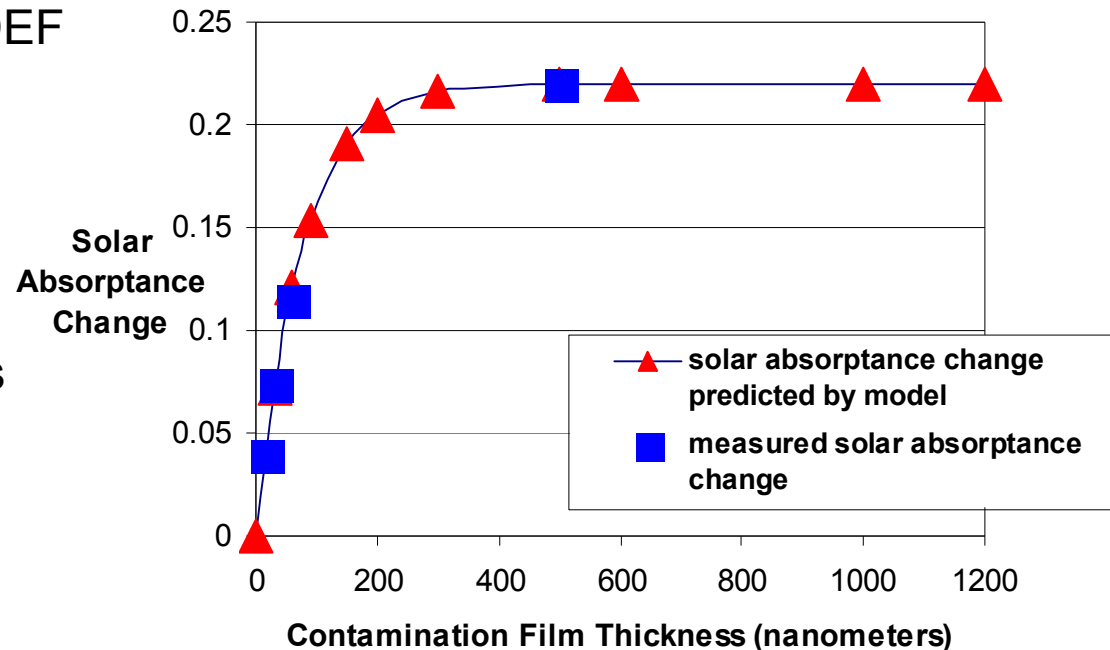
- Measured results from different flights
- Solar absorptance change is for long term (several thousand Equivalent Sun Hours) solar exposure

Solar Absorptance Change after significant solar exposure
as a Function of Contamination thickness

Asymptotic value from LDEF

Two measurements from
Geosynchronous satellite
(AIAA-87-1571)

Solar Max measurements
